## Adaptor M12 on top A-cod./MSUD valve plug CI-9.4mm

3-pol.

Form CI (9.4 mm) - M12, connector top entry 24 V AC  $\pm 20\%$  / DC  $\pm 25\%$ LED and suppression 3-pole

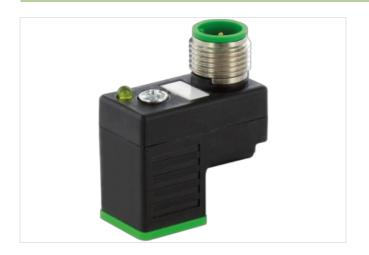
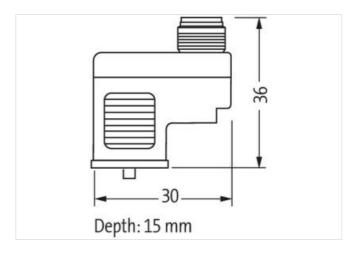
## Illustration

Product may differ from Image

Side 1	
Tightening torque	0,4 Nm
Family construction form	MSUD
Side 2	
Tightening torque	0,6 Nm
